## The Systematic Cleaning and Restoration of Architectural Glass

*This bulletin has been commissioned by the Glass Committee of the International Window Cleaning Association and authored by Paul F. Düffer Ph.D., Educational Program Adjunct to the Glass Committee; Paul D. West, Chairman.*

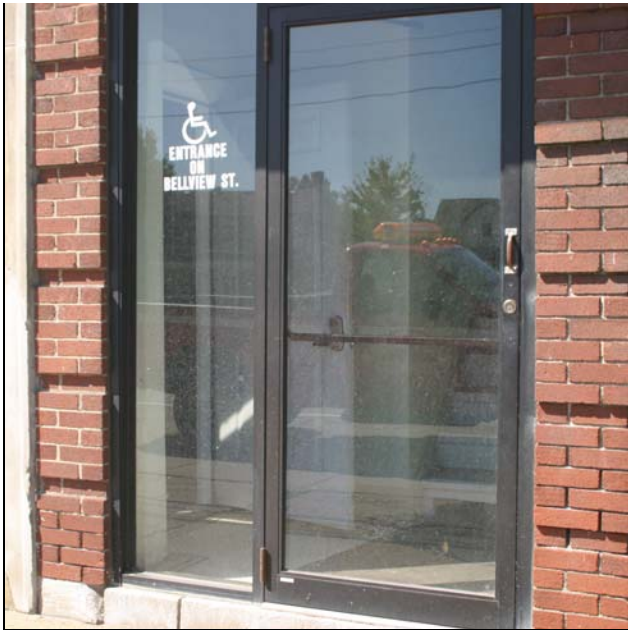
Figure 1: Entrance door on a municipal building located within 30 feet of a busy roadway.

Glass that appears dirty and soiled is often affected by an accumulation of particulates that are characteristic of the everyday environment and not necessarily composed of exotic airborne pollutants. For example, the soiled door shown in Figure 1 exhibits an accumulation of ordinary dust and grime that originated from a relatively commonplace environment.

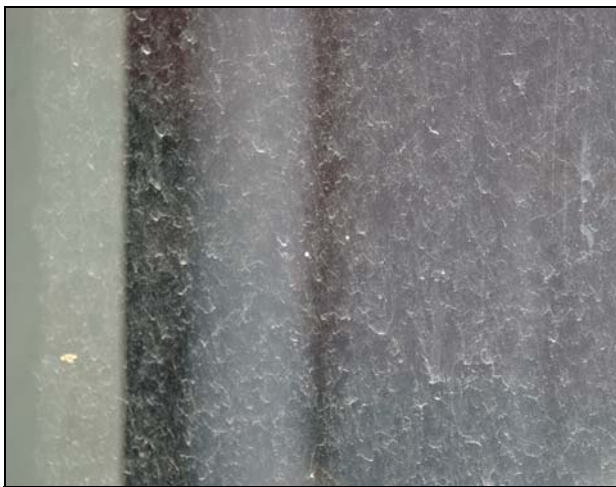
Figure 2: Close-up view of municipal building entry door reveals a significant accumulation of dirt and soil.

A close-up view of the door in question is displayed in Figure 2 and provides a more detailed view of what appears to be a significant amount of dirt and soiling. While this particular view of dirty glass does not appear to be inherently unusual, a different perspective is unveiled by examining this same grit and grime with the aid of a scanning

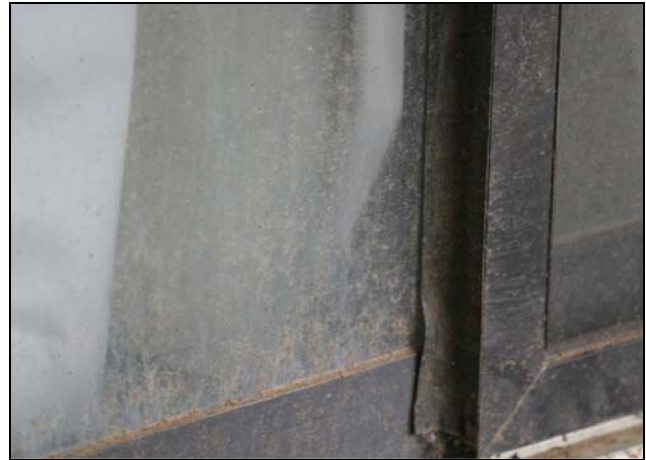
Fig. 5: Close-up view of dirt and soil on window at Virginia vacation home.

A second example of the accumulation of soils and dust on a window glass installation warrants consideration in order to demonstrate that the results cited in the first example are not necessarily unique. In this instance, attention is focused on the vacation home pictured in Figure 4 which is located in the mountains of northwest Virginia. Here again, as was the case with the municipal building door, some significantly soiled glass can be identified as illustrated in Figure 5.

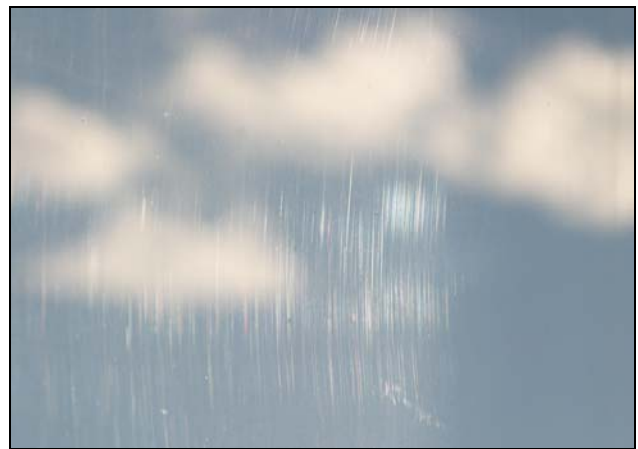
Figure 8: Another example of a window glass surface where the observed scratches are indicative of cleaning in the absence of an experienced professional.

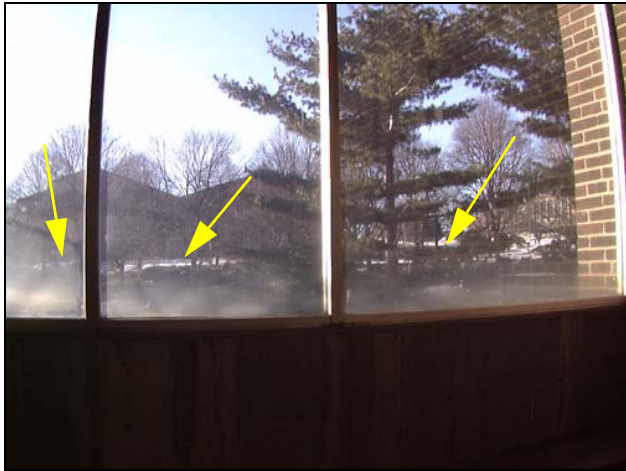
cleaning industries. The focal point of concern has been the typical inability to restore the affected glass to its original condition by means of basic cleaning techniques. For example, the window shown in Figure 9 provides a graphic illustration of the typical outcome associated with such attempts. The close up view of concrete runoff deposits presented in Figure 10 reveals the characteristic pattern associated with this problem.

Figure 9: Visible gray haze due to deposits on glass from concrete runoff. Implementation of conventional cleaning procedures failed to remove deposits.

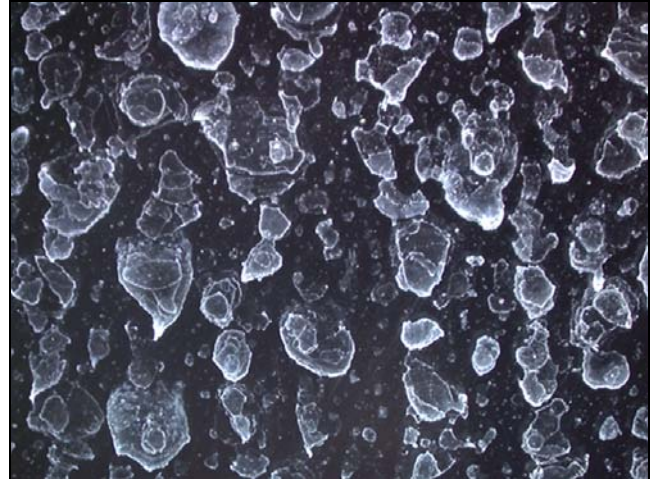
Figure 10: Close up view of typical concrete runoff deposits on glass. These deposits begin to react with glass upon evaporation of the runoff droplets resting on the glass

For many years, conventional wisdom has maintained that runoff from concrete surfaces damages glass due to an alkaline etching or erosion of the surface. However, more recent scientific study has shown concrete runoff to be characterized by deposits of amorphous materials that reside on the glass surface.<sup>3</sup> Whenever rainwater makes contact with a concrete surface, small amounts of silicate materials are dissolved with concentrations of 4 to 8 parts per million being quite common. Upon coming to rest on glass, these dissolved silicate materials gradually become more and more concentrated as the runoff droplets evaporate. Finally, a point is reached where formation of water insoluble polymers begins. This same reaction also results in chemical bonding to the glass substrate. In addition, experiments have shown this process to be significantly more rapid than either glass surface corrosion or true alkaline etching.<sup>4</sup> In fact,

prior work has shown the reaction to reach completion at the point when the water carrier evaporates to dryness. This could take hours or as little as a few moments to occur depending upon environmental conditions.

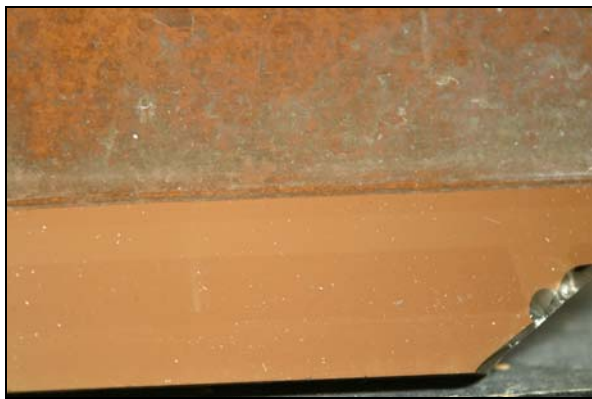
It is important to note that concrete runoff can also have an adverse effect on glass that bears a first surface coating. The same mechanism that produces glass-like deposits on uncoated glass can generate similar entities on coated surfaces with equal facility. Figure 12 reveals the outcome of concrete runoff accumulating on glass with a solar reflective coating on the No. 1 surface. A magnified view is presented in Figure 13. The glass in question had been removed from an existing glazing installation due to suspicions that the coating was defective as a consequence of compromised durability. These reservations arose when it was observed that conventional cleaning failed to restore the glass to its pristine condition. However, subsequent investigation identified the deposits to be silicate residue from concrete runoff

Figure 12. Concrete runoff deposits on coated glass unit removed from an existing glazing installation. Note the line of demarcation at point where glass was protected by framing.

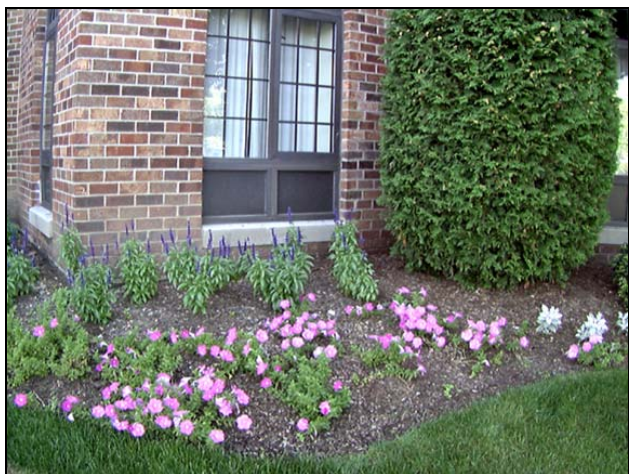
Fig. 14 Hotel window with adjoining decorative garden and hidden pop-up irrigation system.

Another topic that warrants consideration focuses on events that often affect glazing installations situated in suburban settings where glass and decorative landscapes reside in close proximity. In these settings it is not uncommon to observe sprinkler heads that deliver tap water from public or private sources to the ornamental flowers and shrubbery on a regular basis. An example of such an arrangement is shown in Figure 14 where the close proximity of glass and landscape components is clearly illustrated. Hidden from view are pop-up sprinkler heads that rise periodically to irrigate the surrounding area. In these situations, it is not uncommon for the irrigation zone to also include the nearby windows. However, this seemingly

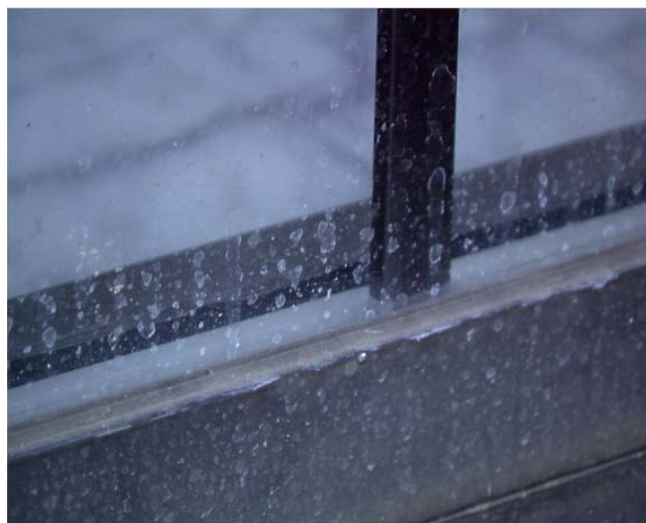
In a manner similar to the process involved in formation of concrete runoff deposits, whenever hard water droplets containing dissolved silicates evaporate, these materials become increasingly more concentrated as the liquid volume decreases.<sup>5,6</sup> Eventually, the silicates begin to bond with one another as well as the glass surface producing what is akin to a “glass-on-glass” deposit. Just like concrete runoff, these glass-like entities fail to respond to common household cleaning agents. Vinegar and other weakly acidic solutions will not dissolve the silicate deposits. A good example of this is shown in Figure 15 which presents a close up view of the window shown in Figure 14. In this instance, repeated contact with hard water droplets from an adjacent lawn sprinkler has created a significant build up of silicate material.

Figure 15 Hard water spots containing silicate materials after normal attempts at cleaning.

The general condition of the window under consideration here suggests that a regularly scheduled program of cleaning and maintenance had not

been implemented by the time the photograph was taken. Of course, the preferred course of action is to prevent such conditions from developing in the first place by consistently employing the services of a window cleaning professional.

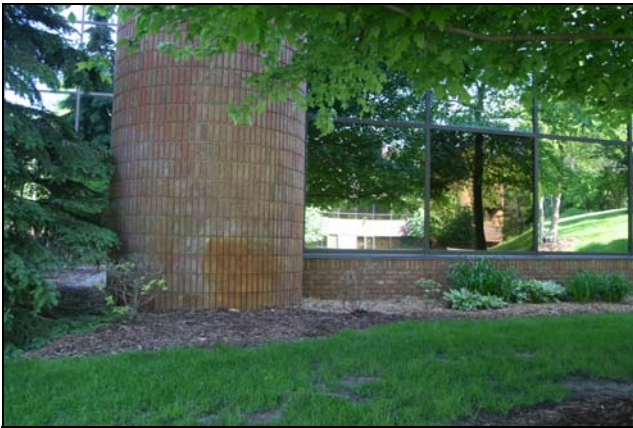
As mentioned previously, the problems associated with removal of silicate deposits from glass are not restricted to uncoated surfaces. Figure 16 presents a view of a suburban office building with adjacent lawn and garden features similar to those observed in Figure 14. However in this instance the glazing system incorporates a reflective coating on the outer or No. 1 surface. Nevertheless, silicate deposits that emanate from hard water spots are equally resistant to removal as illustrated in the close up view shown in Figure 17.

Figure 16 Suburban office building with glass coated on #1 surface.

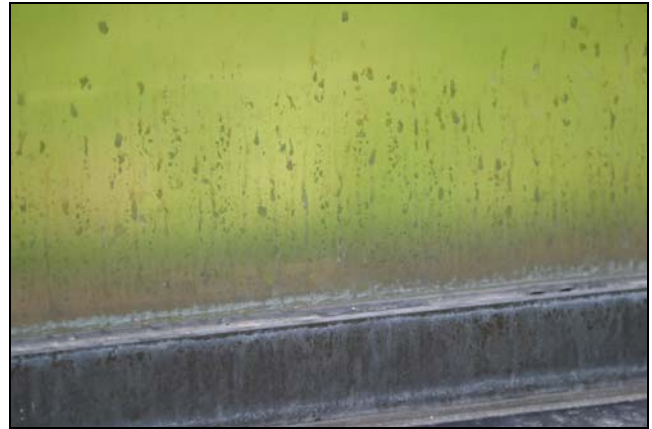
Figure 17: Close up view of silicate deposits on a coated glass surface arising from repeated contact with hard water droplets.

In a manner similar to concrete runoff, the task presented in removing silicate deposits caused by hard water sources is even more difficult for coated surfaces than in the case of non-coated glass. This situation arises from the fact that the structural layers within the family of first surface coatings are quite thin and often vulnerable to the extraordinary mechanical and chemical cleaning procedures required to remove silicate bearing residues. As a consequence, implementation of such cleaning procedures is best left to the skilled professional.
